Instrumentation Monitoring Program to Measure the Magnitude, Distribution and Time Dependency of Drag Load on Abutment Piles: A Case Study

Osama Drbe, Abouzar Sadrekarimi & Hesham EL Naggar,
Western University, London, Ontario, Canada

This paper describes the instrumentation monitoring program including installation, protection, and installation challenges along with initial response of piles' instrumentation to the structural loading during construction.

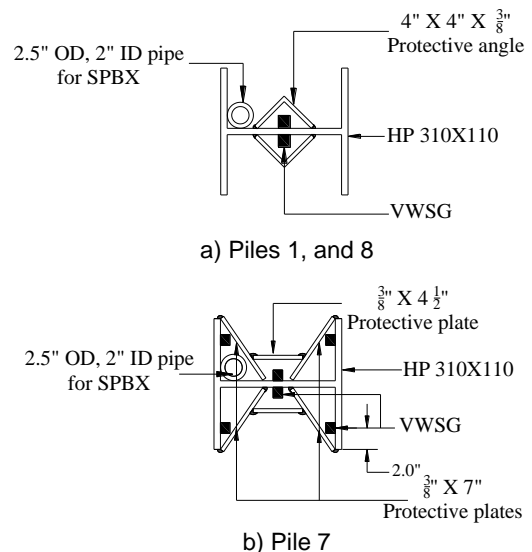
Figure 2. Schematics of pile instrumentation

The total deformation of the pile is to be measured with a single anchor extensometer (SPBX) installed within a 2" mm (50 mm) ID steel pipe welded to the pile (Figure 2). One extensometer was installed on each of the three (3) instrumented piles (denoted as Pile 1, Pile 7, and Pile 8).

Localized strain, and thus the forces on the pile are to be measured using individual strain gauges. The strain gauges were installed in one of two cross-sectional arrangements (Figure 2). The arrangement with only two strain gauges per cross-section is most suitable for determining the average strain due to compression or tension within the cross-section, whereas the arrangement with strain gauges in the flange as well as the web is suitable for identifying those strains induced by bending of the pile. A total of 68 strain gauges were installed at different locations along the pile length including two piles (denoted as Pile 1 and Pile 8) with 16 strain gauges each, and one pile (denoted as Pile 7) with 36 strain gauges. 62 strain gauges out of 68 were installed before driving as following 14, 14, and 34 for piles 1, 8, and 7, respectively. It is worth mentioning that 2 gauges at pile 1 were in the cut-off elevation, so they were cut later. After driving, two strain gauges for each pile were installed at the piles' heads (which they will be embedded in the concrete). Figure 4 shows a vibrating wire strain gauge (VWSG) welded on a steel H-pile.

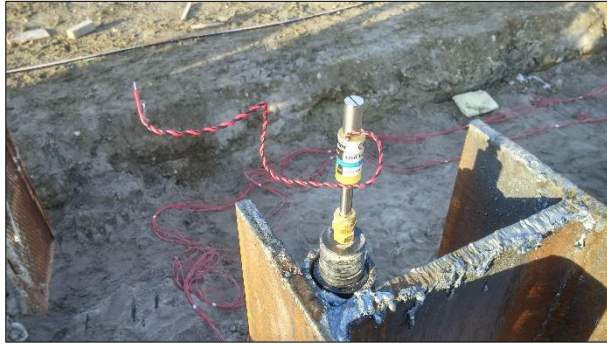
Figure 3. Vibrating wire displacement transducer

The extensometer anchors were set in place using expandable hydraulic anchors after the completion of driving. The deformation of the pile is measured using a vibrating wire displacement transducer installed in the head of the extensometer at the top of the pile as shown in Figure 3. The transducer has a range of measurement of 100 mm.

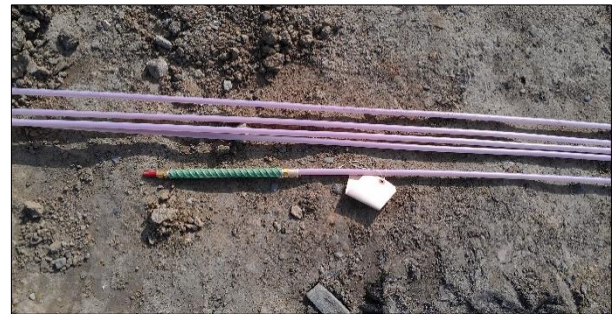
Figure 5. Groutable Anchor

Settlement of the soils beneath the engineered fill is to be measured using a multi-point borehole extensometer (MPBX). Two (2) extensometers were installed adjacent to Piles 9 and 8 (at South and North sides of the northbound lane of the south abutment). Each extensometer had five (5) anchor points that act independently of each other at the installed depth. Each anchor (Figure 5) was grouted in place using a grout mix that is compatible with the local soil conditions.

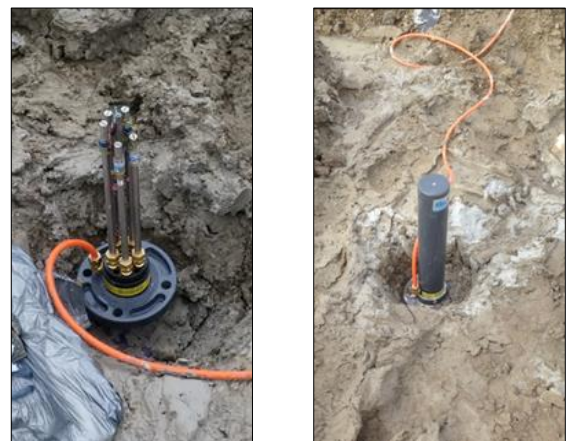
Figure 6. Head of multi-point borehole extensometer

A fiberglass rod with a sheathing to isolate it from the surrounding soils is used to connect the anchors to the extensometer's head. A vibrating wire transducer with a measurement range of 200 mm was connected to the rod at the head of the extensometer for each of the five anchors as shown in Figure 6. Displacements between the location of the head and the individual anchors are measured. The extensometers were installed after pile driving was complete. It should be noted that a traditional survey of the completed structure has been undertaken by the MTO's geomatics department to verify the overall settlement of the structure, inclusive of the piles and engineered fill.

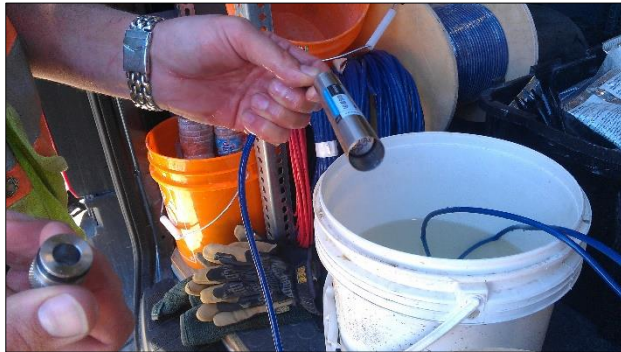
Figure 7. Vibrating Wire piezometer

Porewater pressure in the soils adjacent to the instrumented piles are to be measured by vibrating wire piezometers (Figure 7). Ten (10) piezometers (VWPs) were installed between four (4) locations with three of the locations consisting of clusters of three (3) instruments distributed vertically, and one reference piezometer located outside of the expected zone of influence of construction. The chosen piezometers had a pressure range of 350 kPa. All piezometers were installed prior to pile driving.

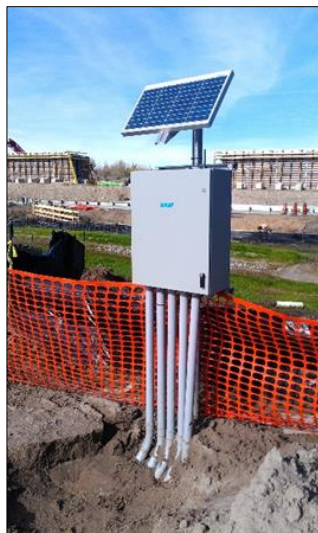
Figure 8. Automated data acquisition system (ADAS)

An automated data acquisition system (ADAS) with remote data management system (RMDS) capabilities was chosen for this project. The ADAS (Figure 8) consists of seven (7) multiplexers (MUX), a datalogger, a solar charging unit, and a battery sufficient to run the system for greater than two (2) week without charging. A grounding rod and surge protection module were installed for lightning surge protection. In addition, a cellular modem is used to transmit the data such that additional processing at an offsite server may be conducted and to allow access to the processed data by all invested parties.

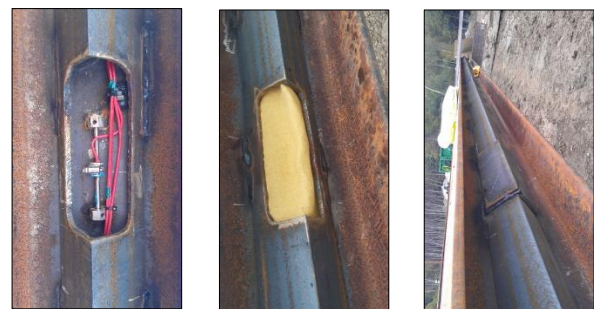
Figure 9. Protection measures for Piles 1 and 8

As can be expected the welding of this steel in close proximity to the installed instruments and the even more susceptible cables presented a risk of fire or at least melting. To prevent the fire at the expected locations of concern a fibreglass welding divider sheet was cut to size and permanently installed along the instruments and cables within the steel protection areas. In the expected areas of exposure no cables or strain gauges were lost during the welding or cut-offs. Pinch and rubbing risks at the exit point of each pile was addressed using padding and/or rubber sheathing to isolate the cable from the metal edges. There was a cable damage in an area that will be discussed in Section 9, which was damaged during pile cut-off. Figure 9 shows the protection of the VW strain gauges of Piles 1 and 8 from heat and frictional forces

a) Covering the cables, and sensors by a fire resistance fabric b) Adding extra piece of protecting angle

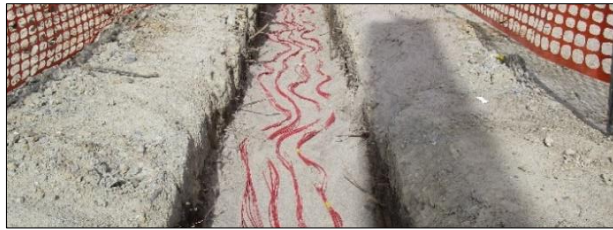
Figure 10. Serpentine layout of cable bundles

The estimated settlement at this site is expected to be in the range of 150 mm, as such, high levels of strain in the cables, which can lead to jacket failure or in extreme cases cable breakage, had to be addressed. Cables at this site were laid out in a serpentine fashion (Figure 10) with about 200 mm of clean sand sized material separating different layers of cabling. It remains to be seen if there are any failures due to cable strain. This will not be fully determined until the settlement or study period is complete.

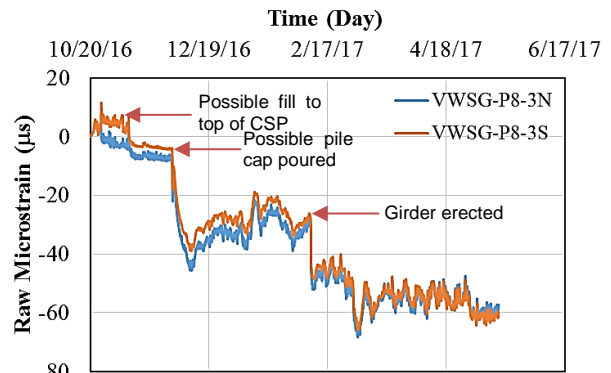
Figure 11. Raw Microstrain vs. Time (mm/dd/year format)

Figure 11 shows the response of vibrating wire strain gauges at depth 3 of Pile 8 due to the piers loads and girders (Figure 12). The negative sign (-ve) in Figure 11 indicates that the gauges are in compression due to the external loads. Figure 13 shows the location of vibrating wire strain gauges at depth 3 of Pile 8.

The attempt to measure residual stresses by comparing the readings before and after installation was failed as it was indicated that drift of strain gauges readings occurred due to driving. For this case, the most suitable baseline was that measured post driving after the driving induced strains had stabilized.

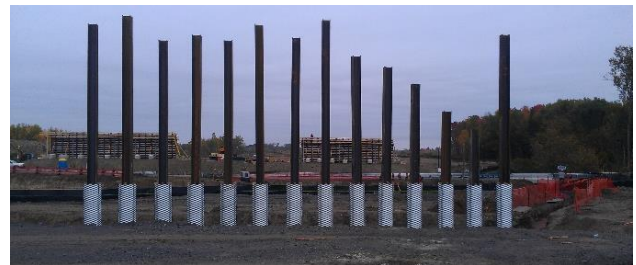
Figure 14. Installation of corrugated steel pipes

It was originally understood that the placement of sand within the corrugated steel pipes (CSP) surrounding the protruding piles (Figure 14) was to occur prior to the cut-off to the excess pile lengths. Unfortunately, this did not occur in one location, and due to the absence of this or an alternate protective measure, debris and heat from an oxyacetylene torch created a fire which in a short period of time damaged many cables on a single pile. Splicing each of the damaged cables, while time consuming, did allow for the salvaging of all the damaged instruments.

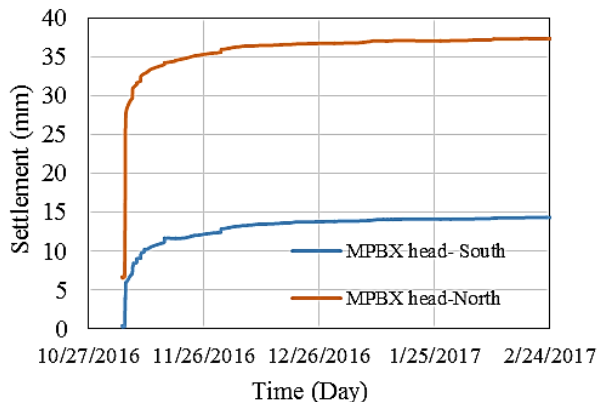
Figure 15. Settlements measured during construction (time is in mm/dd/year format)

Generally, an MPBX should be installed several days prior to any anticipated ground movement to allow the MPBX to stabilize. After installation, slight movements may occur but generally cease after three (3) days. Initial readings shall be taken several times to ensure a good baseline reading. After installing the south and north MPBXs (on November 4th, 2016), settlement values of 0.4 mm, and 6.7 mm were respectively measured in this project. A day after (on November 5th, 2016) and during some earthwork construction activities, a sharp increase to about 14 mm and 35 mm was observed in the settlement readings of the south and north MPBXs respectively as shown in Figure 15.

The initial interpretation for the possible causes of these higher values of settlement is that since the MPBX anchors were installed in an unstable layer and/or the bentonite grout had not hardened enough, the heads of MPBXs were somewhat displaced by earthwork activities. The north MPBX was installed 2 days after the installation of the south MPBX, which could partly explain the different amounts of settlement measured by these MPBXs.
